Attachment 4: Wetland and Waters of the U.S.
Memorandum – Ogden Dunes Additional Parcels

Date:	Tuesday, May 26, 2020
Project:	DT-NWI Project
To:	Nicole Barker, NICTD
From:	Janice Reid, Project Manager, HDR Andrea Cline, Senior Environmental Scientist, HDR
Subject:	Double Track – Northwest Indiana (DT-NWI) Project Ogden Dunes Additional Parcels: Wetland Assessment Report

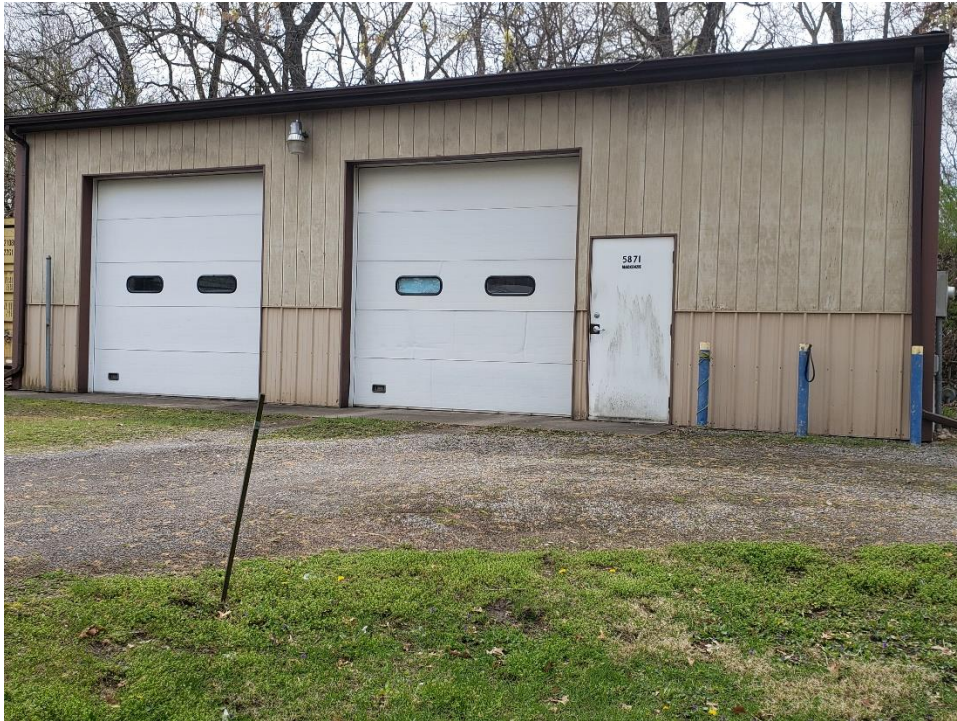
Data point 1B

The study area contained two houses, a warehouse, two driveways, mowed lawn, and upland treed areas, as shown on the attached Exhibits. The study area is characterized at data points 1B and 2B. The vegetated portions of the study area were dominated by red oak (*Quercus rubra*) and multiflora rose (*Rosa multiflora*), and box elder (*Acer negundo*) and Kentucky bluegrass (*Poa pratensis*). No wetlands or waters were identified within the study area.

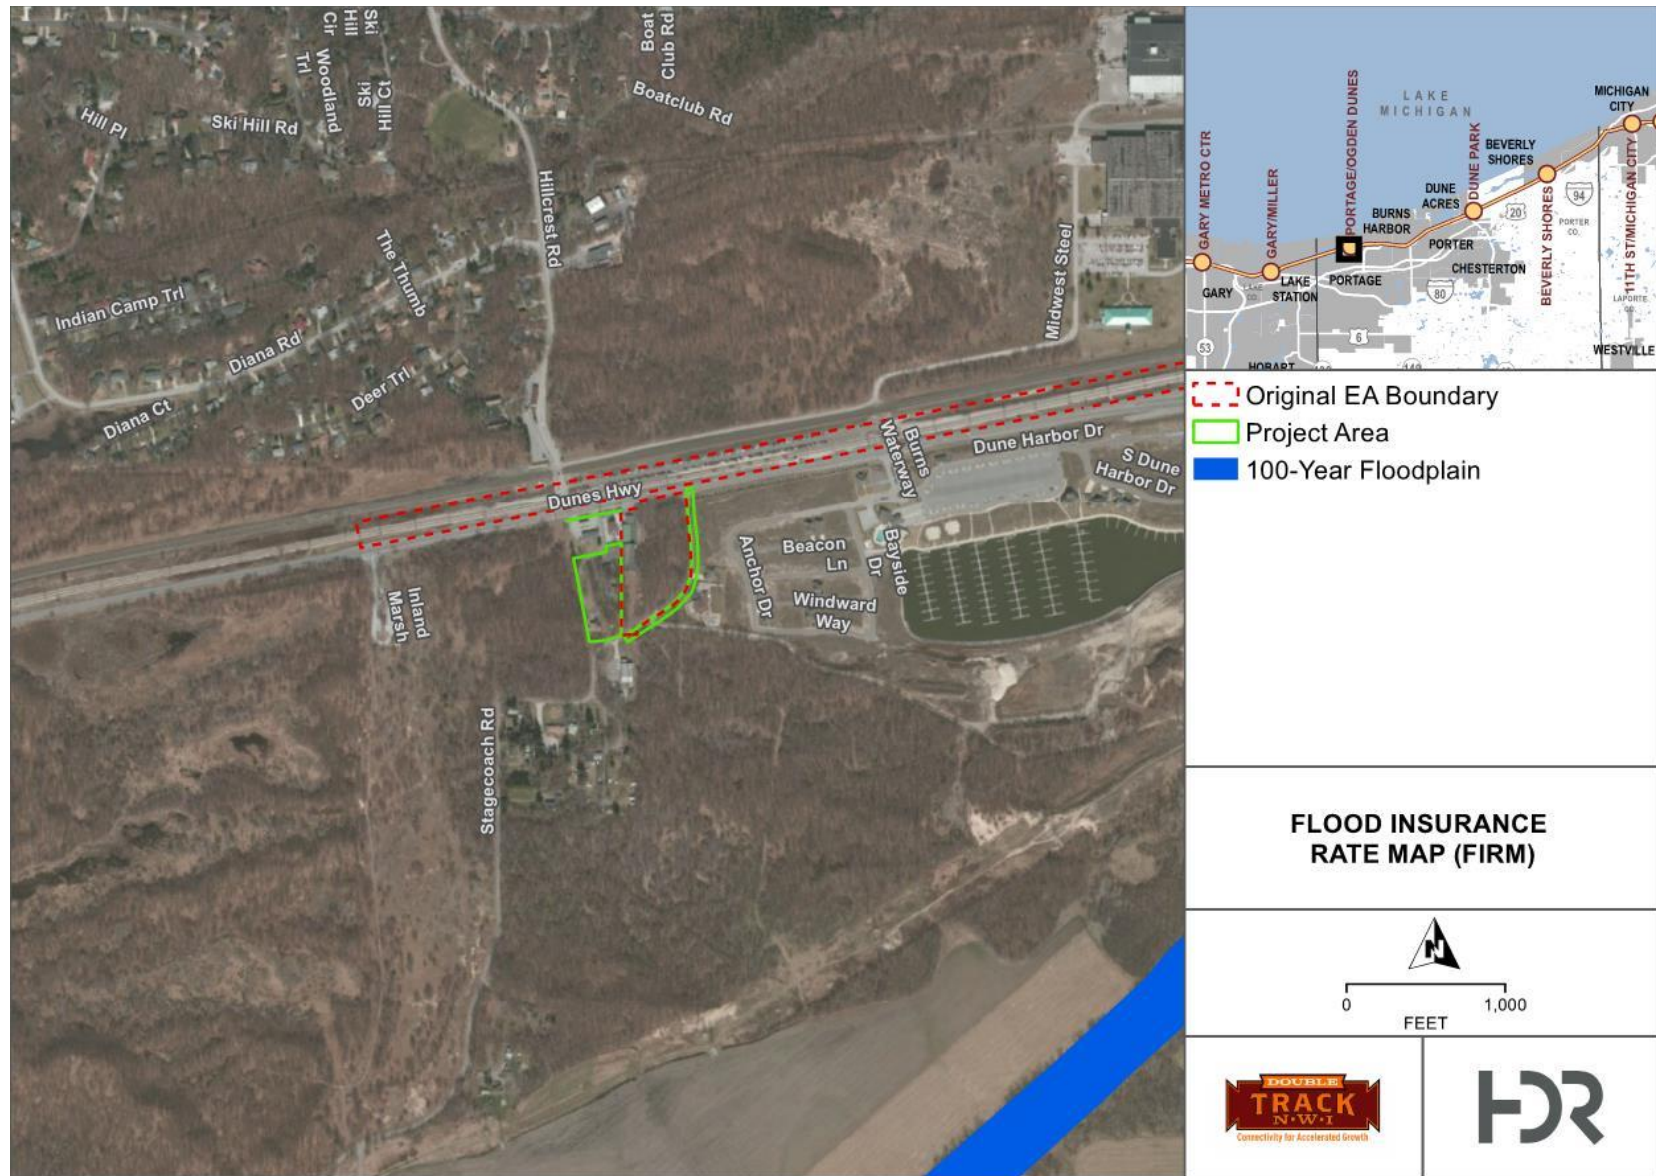
Exhibit 5: Flood Insurance Rate Map

The Flood Insurance Rate Map (FIRM) for Porter County, Indiana and Incorporated Areas, Map Number 18127C0102D (effective September 30, 2015) was reviewed to determine the locations of regulatory floodplain on site. The presence of floodplain can be indicative of wetland hydrology. The FIRM indicated that there is no floodplain mapped with in the study area.

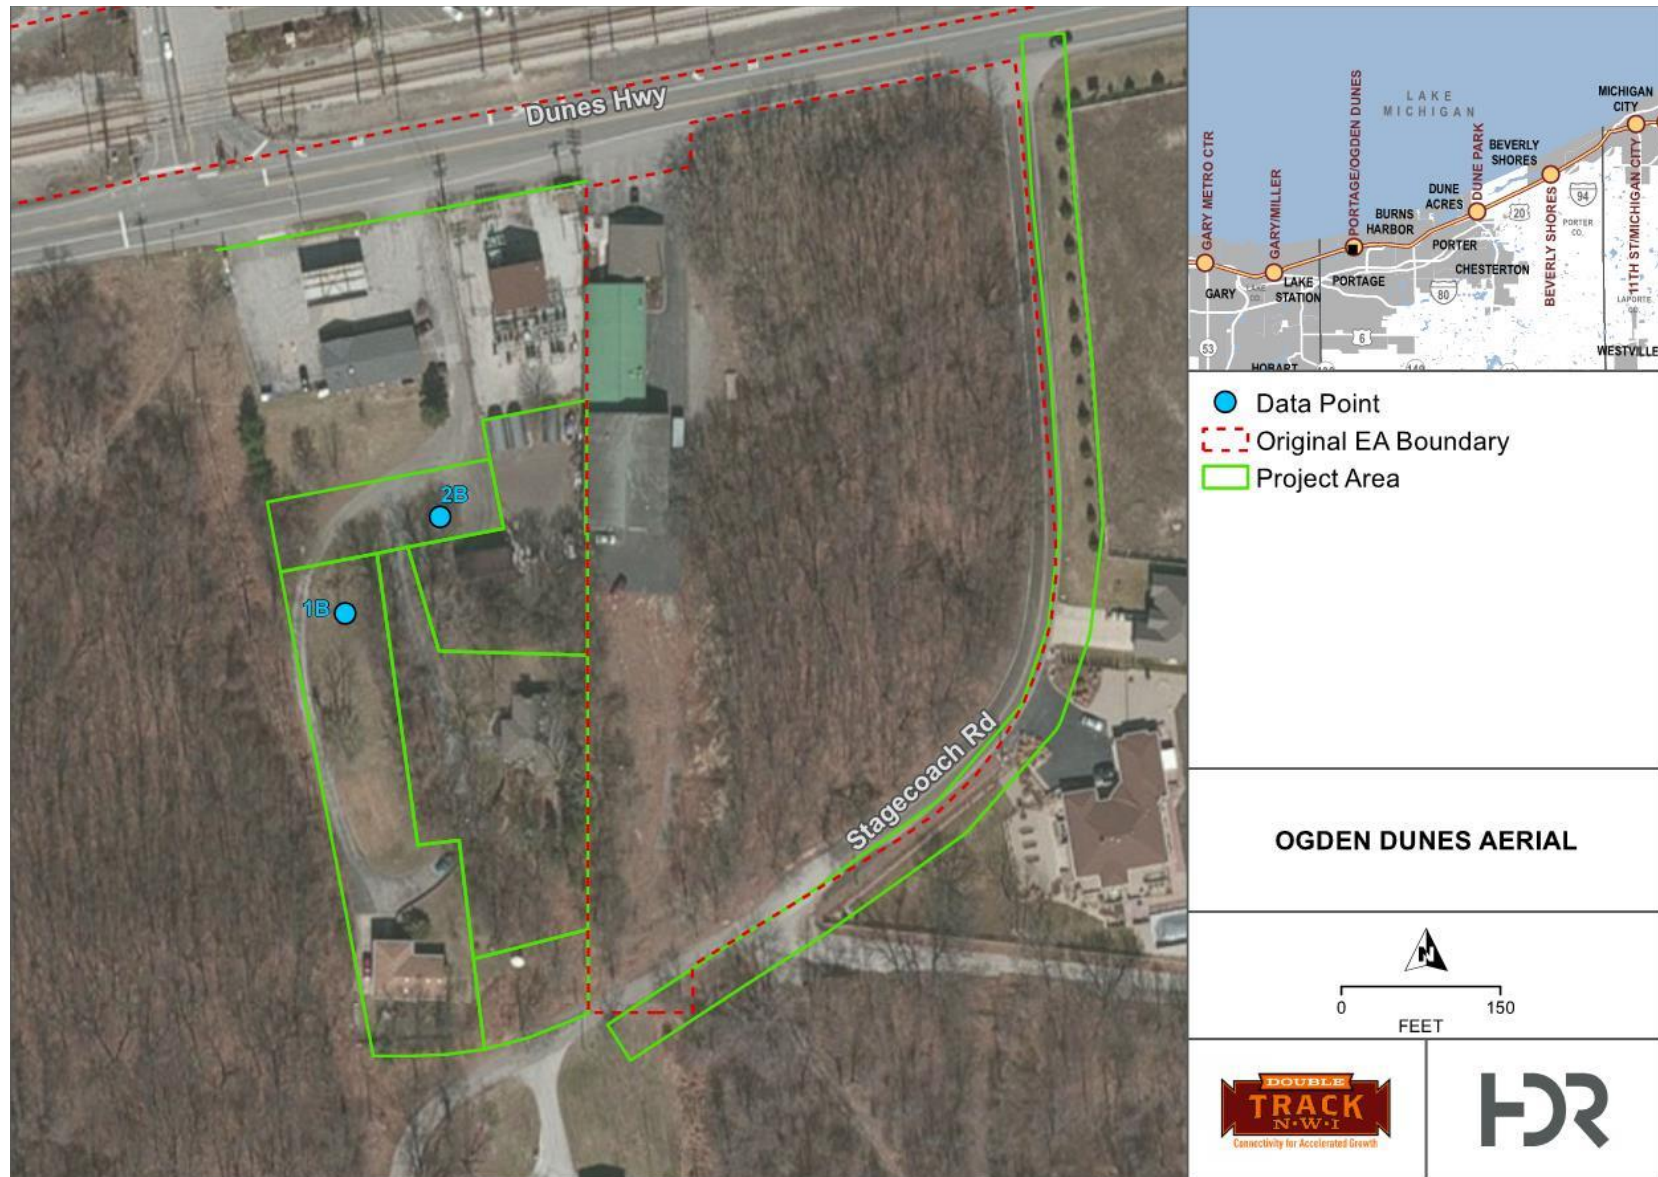
Exhibit 6: Ogden Dunes Aerial

The study area is located south of US Highway 12 and west and north of Stagecoach Road and consists of five separate residential parcels. The Parcel Identification Numbers (PIN) are 6402352014000017, 640235252009000017, 640235252013000017, 640235252008000017, and 640235252010000017. No wetlands nor waters were identified within the study area. The delineation was completed in accordance with the Regional Supplement to the Corps of Engineers Wetland Delineation Manual: Midwest Region (October 2010). An aerial photograph of the site with data point locations is shown on Exhibit 6. Information collected on site is listed in the attached data forms.
